Manhole Inspection Summary

Manhole # S23K__035MH

Insp Date: **6/10/08 10:46 AM**

Location Address: **237 McHenry**

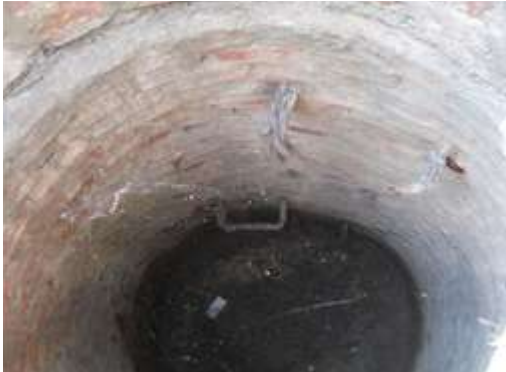
Defect 5

Condition: ☐ Sound ☐ Cracked ☐ Root Intrusion ☐ Loose Brick ☒ **Deteriorated**

Infiltration: ☐ None ☐ Joint ☒ **Cracks** ☒ **Mortar** ☐ Roots ☐ Wall

chimney deterioration and infiltration at frame-lid

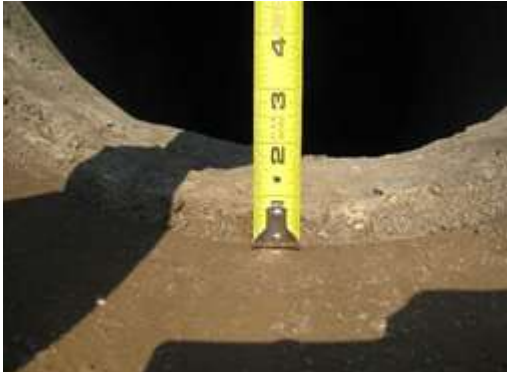
Defect 6

Offset: **1** (in.)

Condition: ☐ Sound ☐ Cracked ☒ **Leaks**

1 inch frame offset

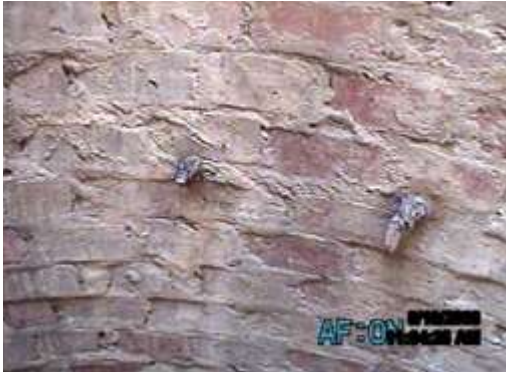
Defect 3

missing rungs

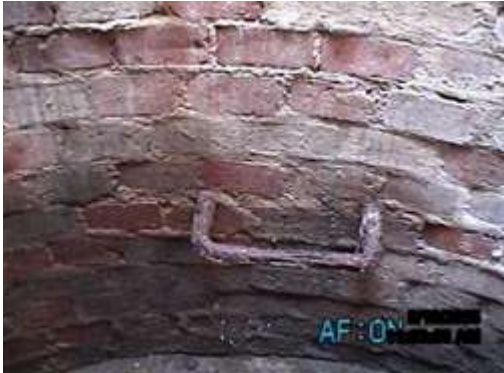
Defect 2

corroded rungs

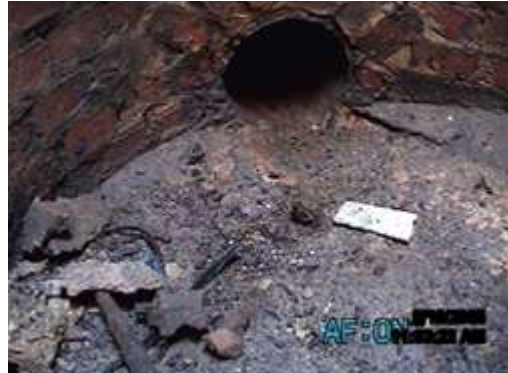
Defect 1

debris

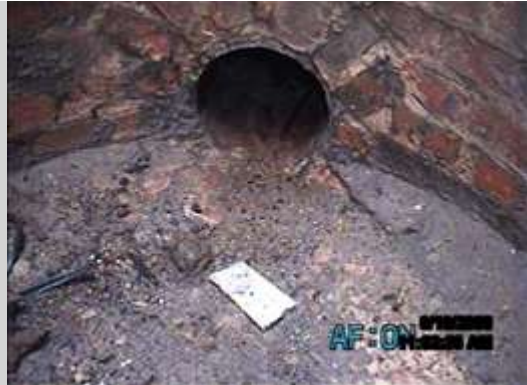
12 O'Clock Outflow

8 in. Circular Gravity Sewer
Pipe Out @ 12 O'Clock

Infiltration: **None** Pipe Seal Cond: **Sound**
